# LYONS COMMUNICATIONS CENTER

Lyons Communications Center | AUTOVON | Lyons AT\_T 1975

# American Telephone and Telegraph Company

LYONS, NEBRASKA

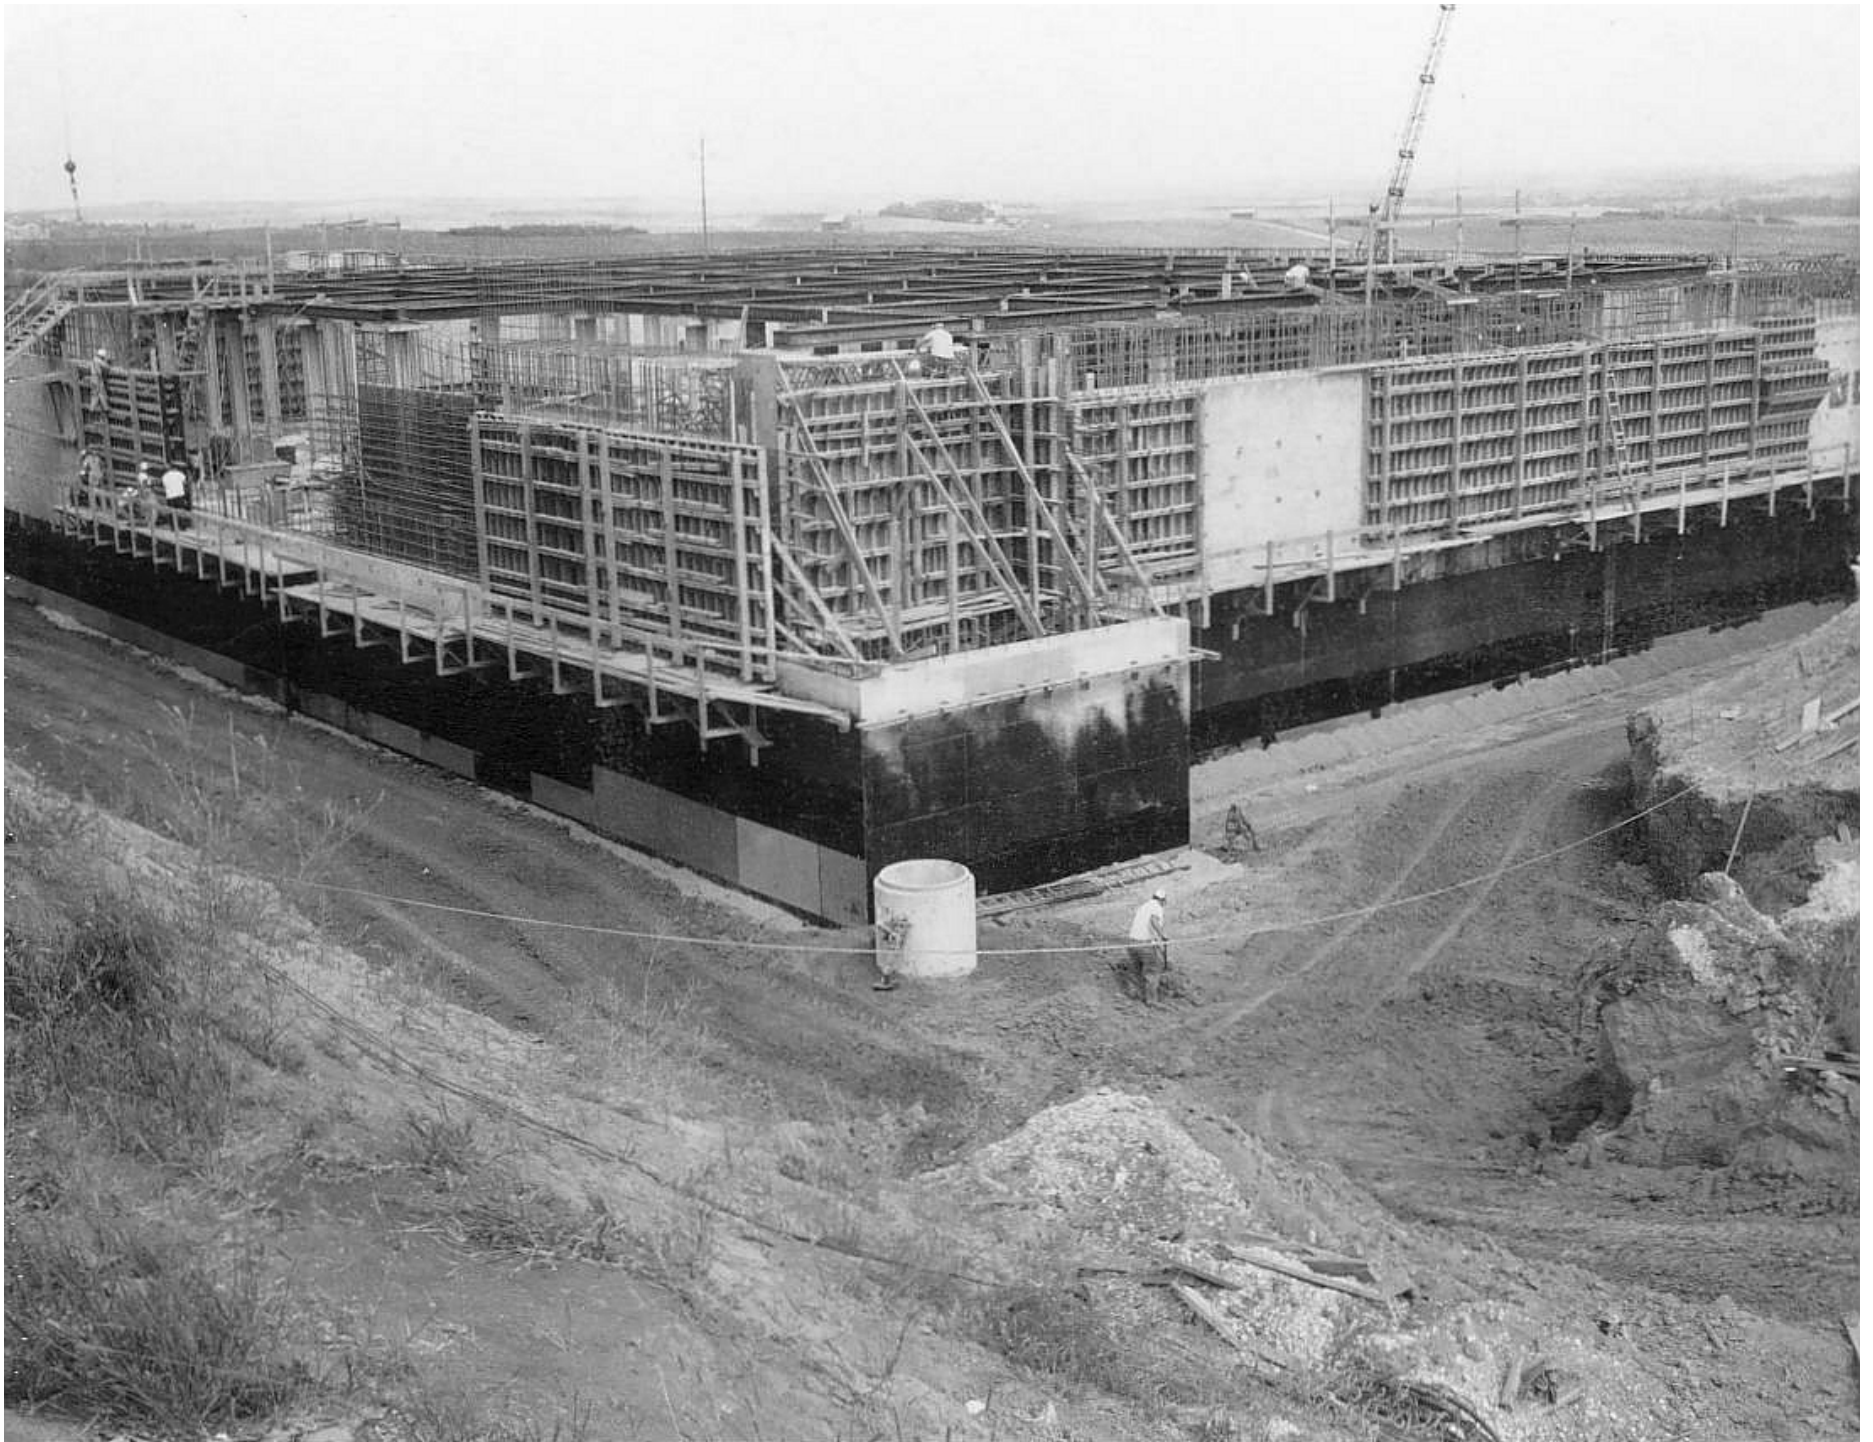
Lyons Communications Center | AUTOVON | 9-8-67 The only honeycombed area of any consequence in the b

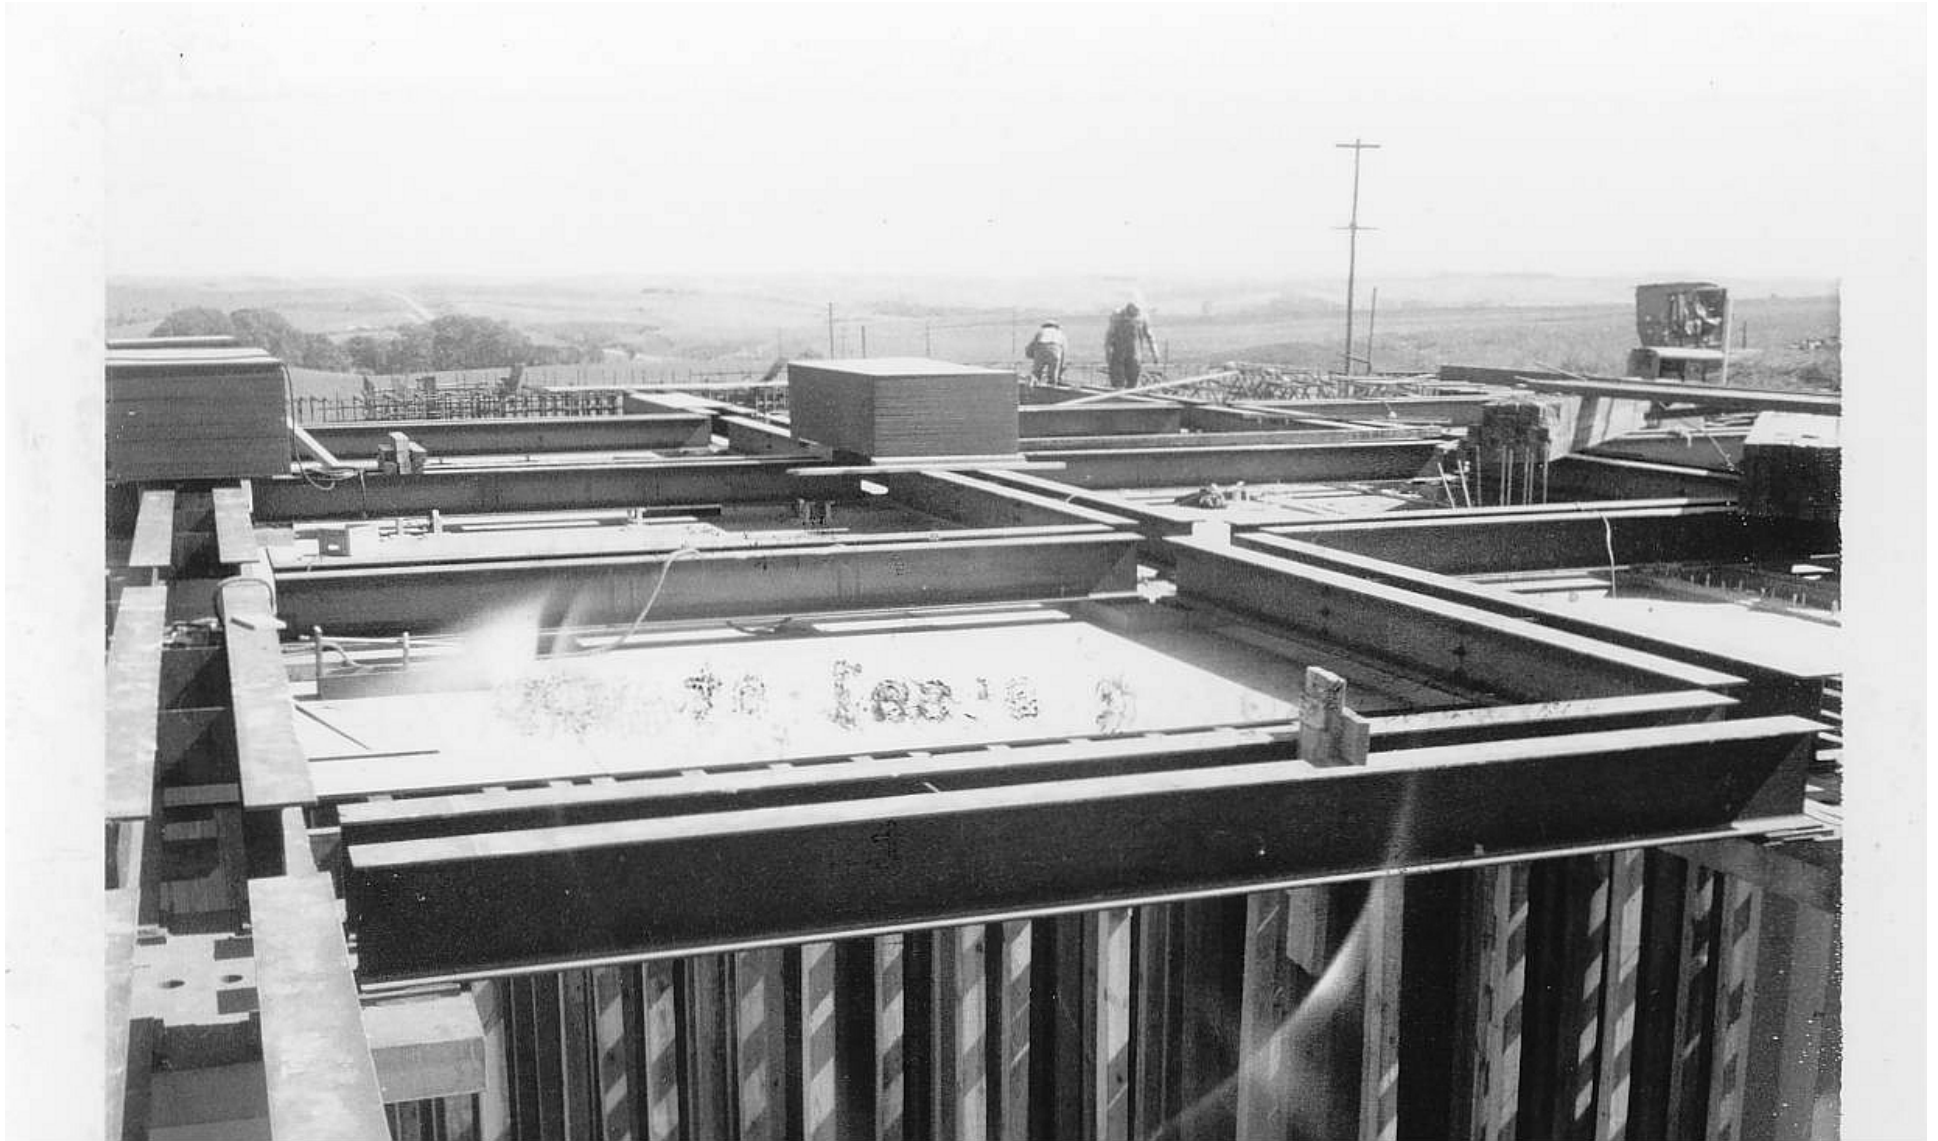
Lyons Communications Center | AUTOVON | 9-25-67 Excavation in backfill of bulding required to uncove
