# LYONS COMMUNICATIONS CENTER

Lyons Communications Center | AUTOVON | Lyons AT\_T 1975

# American Telephone and Telegraph Company

LYONS, NEBRASKA

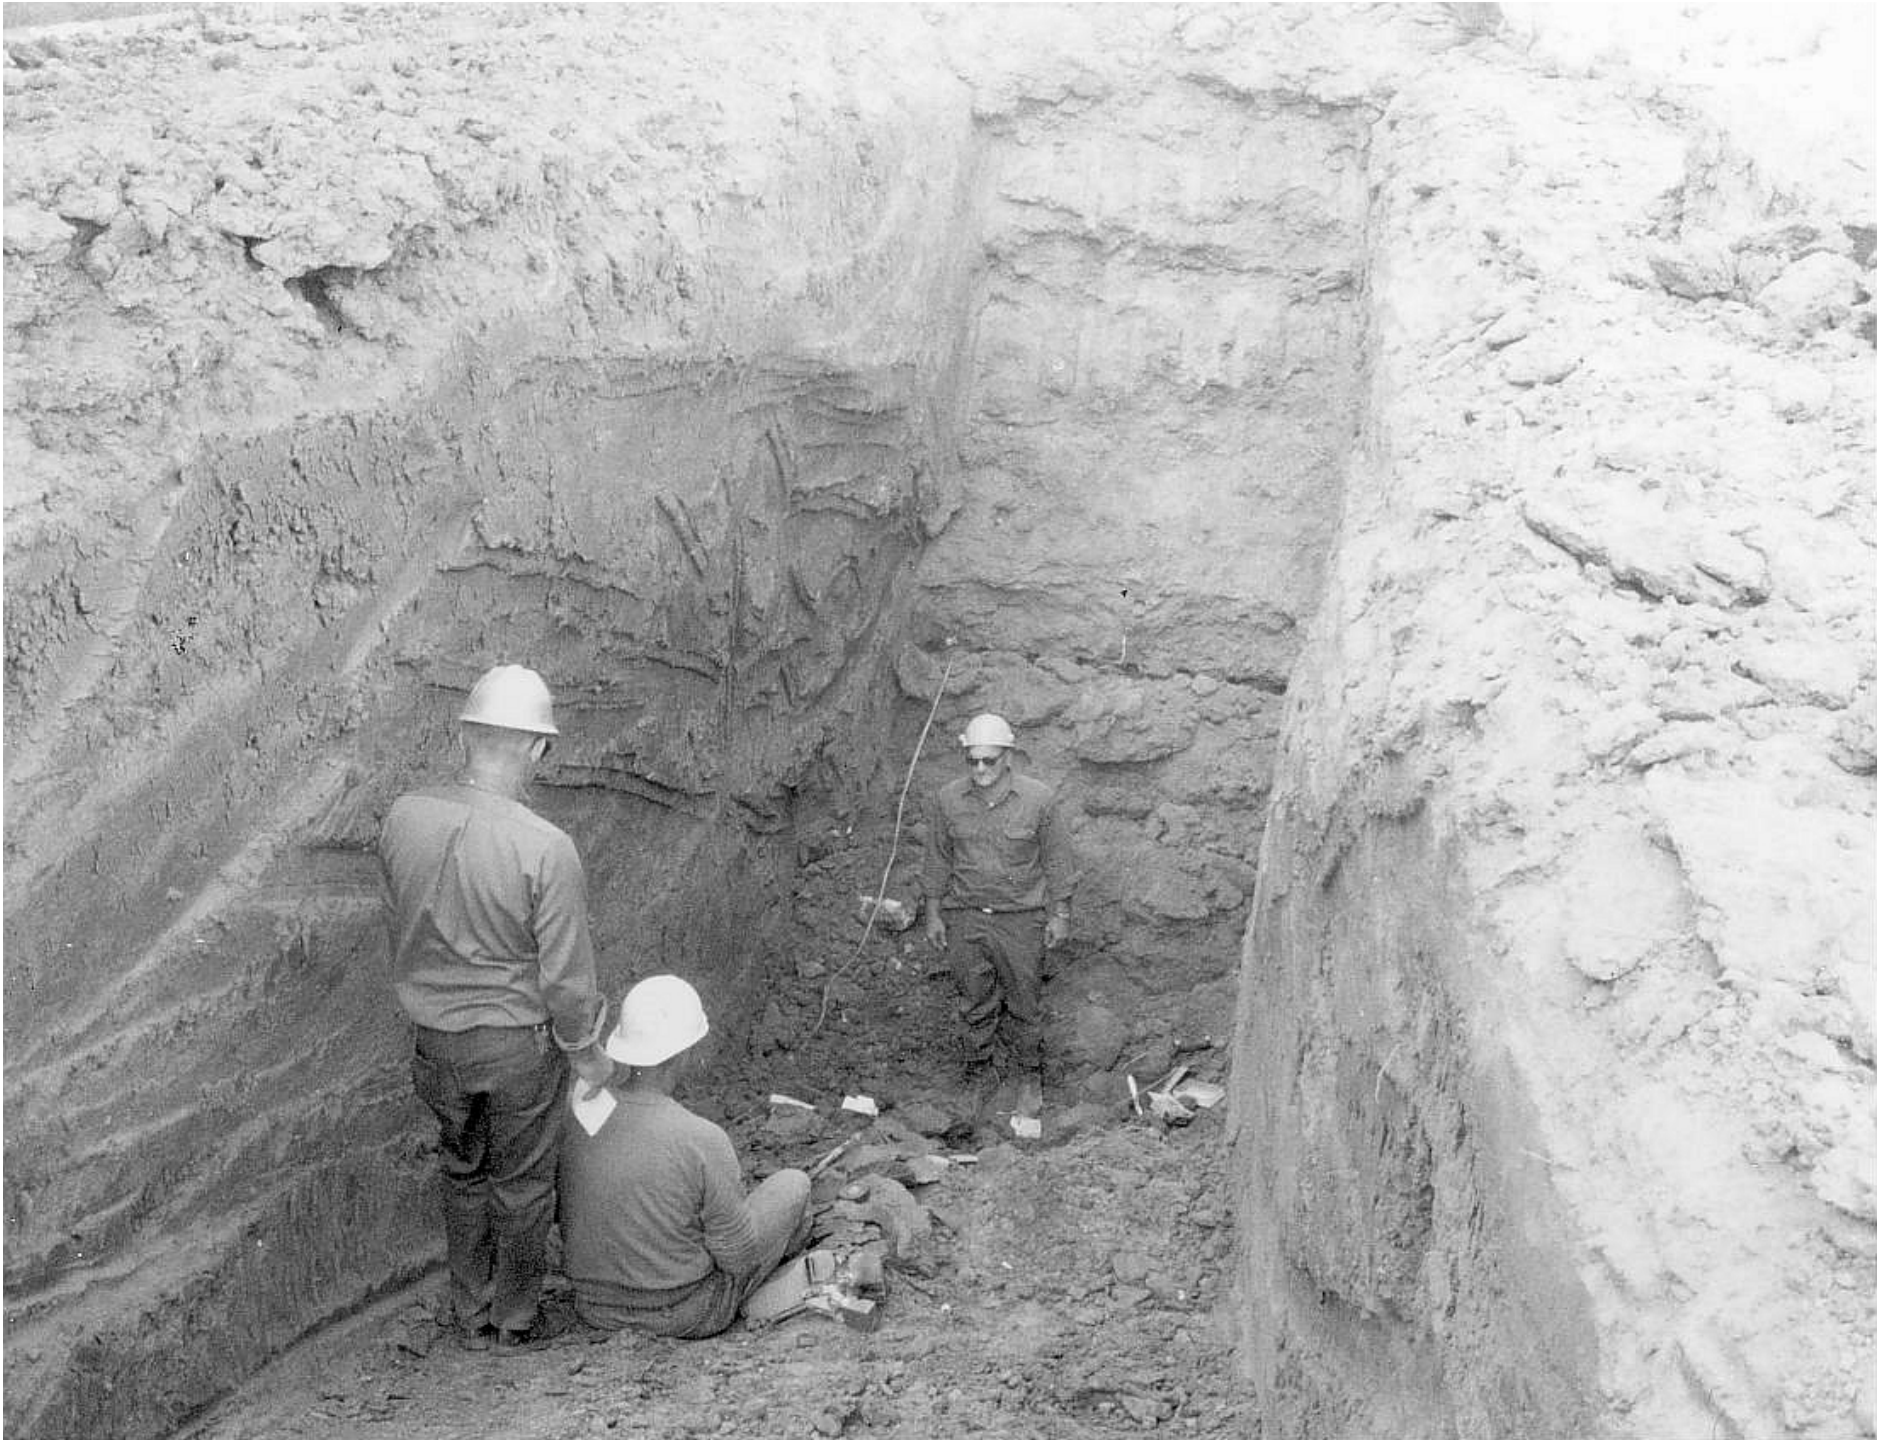
Lyons Communications Center | AUTOVON | 9-25-67 Excavation in backfill of bulding required to uncove
